[Docket No. FAA-2016-9254; Directorate Identifier 2015-CE-030-AD; Amendment 39-18948; AD 2017-14-04]

Airworthiness Directives; Piper Aircraft, Inc. Airplanes

2017-14-04 Piper Aircraft, Inc.: Amendment 39-18948; Docket No. FAA-2016-9254; Directorate Identifier 2015-CE-030-AD.

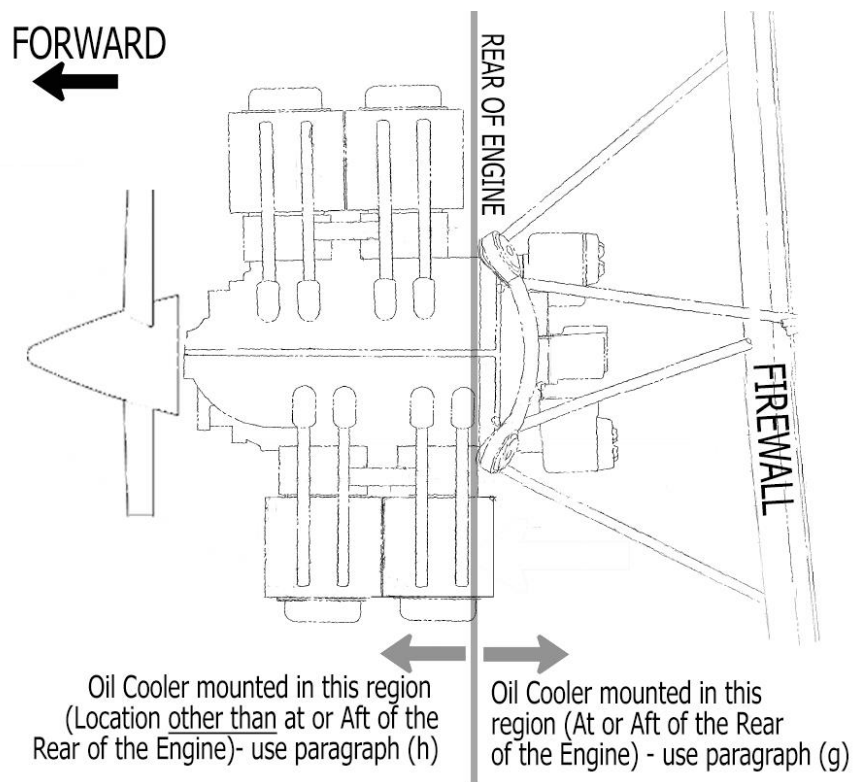
Figure 1 to paragraphs (g) and (h) of this AD: Oil cooler

AD 95-26-13 was prompted by numerous incidents/accidents caused by rupture or failure of the oil cooler hose assemblies. This AD action was prompted by requests to clarify the intent of AD 95-26-13. We are issuing this AD to prevent rupture or failure of the oil cooler hose assemblies, which could result in engine stoppage with consequent loss of control.

For any oil cooler hose assemblies that do not meet TSO- C53a, Type D requirements: Within the next 100 hours time-in-service (TIS) after February 5, 1996 (the effective date retained from AD 95-26-13), and repetitively thereafter at intervals not to exceed 100 hours TIS, inspect the fire sleeve of each oil cooler hose assembly for soaked oil, a brownish or whitish color, and any evidence of brittleness or deterioration as a result of heat or oil seepage. See figure 1 to paragraphs (g) and (h) of this AD for additional information.

hours TIS, inspect the fire sleeve of each oil cooler hose assembly for soaked oil, a brownish or whitish color, and any evidence of brittleness or deterioration as a result of heat or oil seepage. See figure 1 to paragraphs (g) and (h) of this AD for additional information.

(1) If any of the conditions described in paragraph (g) or (h)(1) of this AD are found on an oil cooler hose assembly during the inspection required in paragraph (g) or (h)(1) of this AD, as applicable, before further flight, replace the oil cooler hose assembly with a serviceable new or used TSO-C53a Type D oil cooler hose assembly or TSO-C53a Type C oil cooler hose assembly. If a used TSO-C53a Type C oil cooler hose assembly is installed, it must have documented hours TIS.

(1) When a TSO-C53a Type C oil cooler hose assembly accumulates 8 years or 1,000 hours TIS, whichever occurs first, replace the oil cooler hose assembly with a serviceable new or used TSO-C53a Type D oil cooler hose assembly or TSO-C53a Type C oil cooler hose assembly. If a used TSO-C53a Type C oil cooler hose assembly is installed, it must have documented hours TIS. If the newly installed oil cooler is a TSO-C53a Type C oil cooler hose assembly and it is mounted in a location other than at or aft of the rear of the engine the installation must meet the conditions listed in paragraphs (h)(2)(i) through (iii) of this AD.

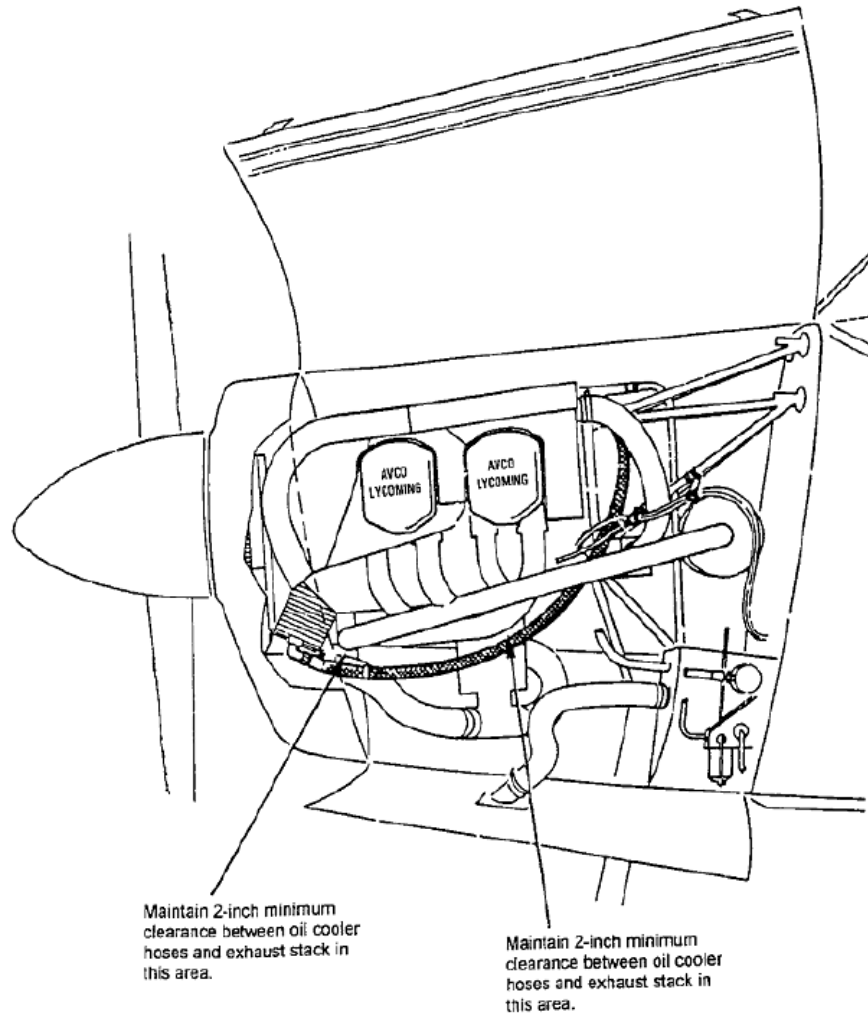
Figure 2 to paragraph (h)(2) of this AD: Acceptable clearances

(2) For any oil cooler hose assemblies that do not meet TSO- C53a, Type D requirements: Within the next 100 hours TIS after February 5, 1996 (the effective date retained from AD 95-26-13) and repetitively thereafter at intervals not to exceed 100 hours TIS, inspect the oil cooler hose assemblies to ensure the installation conditions in paragraphs (h)(2)(i) through (iii) of this AD are met. See figure 1 to paragraphs (g) and (h) of this AD for additional information. If the conditions listed in paragraphs (h)(2)(i) through (iii) of this AD are not met, before further flight, make any necessary adjustments. See figure 2 to paragraph (h)(2) of this AD for additional information.

(i) The oil cooler hose assemblies pass underneath and behind the electrical ground cable and in front of the lower of the two engine mounts.

(ii) The oil cooler hose assemblies are secured to the engine mount strut and a clearance of at least 2 inches exists between the oil cooler hose assemblies and the exhaust stack.

(iii) Oil cooler hose assemblies with a minimum outer diameter of 0.75 inch are installed with a bend radius of at least 6.5 inches.

(2) If a newly installed oil cooler hose assembly is a TSO-C53a Type C oil cooler hose assembly and it is mounted in a location other than at or aft of the rear of the engine, then replacement of the oil cooler hose assembly must meet the conditions listed in paragraphs (h)(2)(i) through (iii) of this AD.
